**US Army Corps
of Engineers**

Waterways Experiment
Station

Miscellaneous Paper CHL-98-6
August 1998

Toussaint River Unexploded Ordnance (UXO) Demonstration Dredging Project

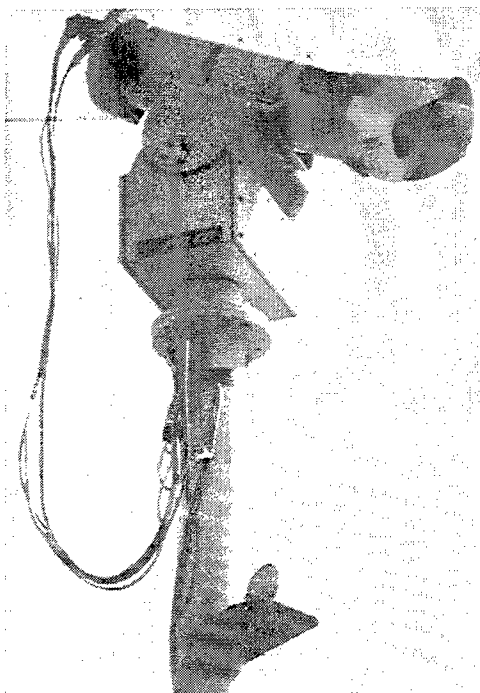
an explosion-proof and waterproof enclosure equipped with remote-controlled pan and tilt capabilities (Figure 7).

The screening process was visually monitored by EOD personnel in the observation trailer (OBST). Human Factors Applications Incorporated (HFA) of Holicong, Pennsylvania, provided EOD support during the demonstration in the form of equipment and personnel to locate, identify, recover, transport, and dispose of ordnance encountered. The OBST was equipped with a steel protective barrier and polycarbonate viewport on the side facing the screen (Figure 3). During the actual dredging, all personnel except the water cannon and crane operators were stationed inside the OBST. A closed-circuit television (CCTV) high-resolution camera lens was mounted on a 4.6-m (15-ft) mast near the screening area. The camera's 10X f1.8 motorized zoom lens with auto iris was housed in

Figure 7. 10X zoom lens with remote-controlled pan and tilt

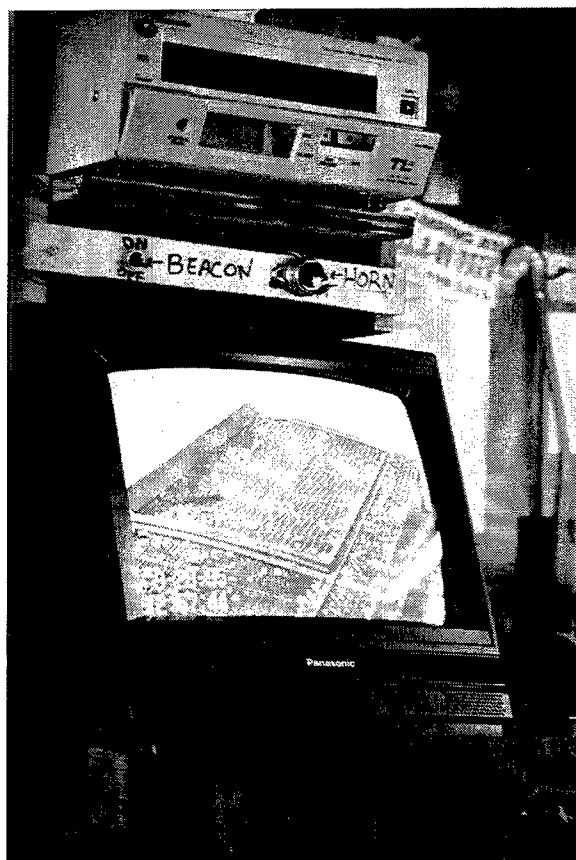
An operator in the OBST controlled the camera's zoom, pan, and tilt functions. A color video monitor and time-lapse recorder were connected to the camera via a fiber-optic link to provide color-corrected professional-quality images (Figure 8). The CCTV field of view provided coverage of the entire screen surface. As a surveillance system backup, one EOD person monitored the screening process by looking out the view port with binoculars.

Figure 8. CCTV control station inside the OBST (lens zoomed out)

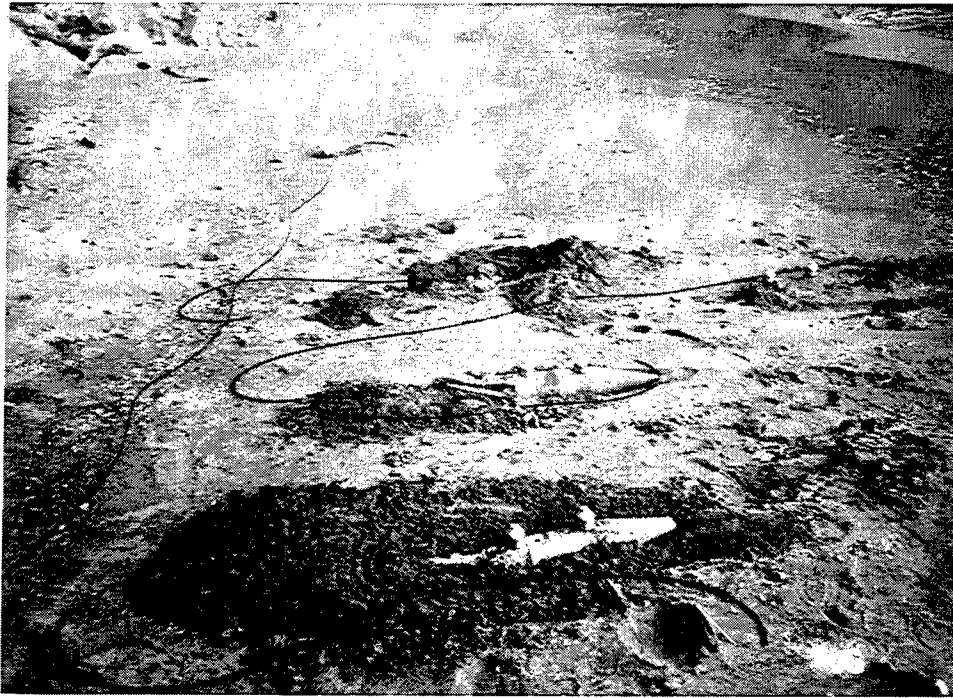
If the target was ordnance, as it was after the 8th day of dredging (a smoke grenade and 106-mm projectile), a 5-m (16-ft) diesel-powered (reduced fire hazard) boat piloted by another EOD specialist would be brought up alongside and the ordnance would be sand-bagged, and transported to shore. At the disposal site, the ordnance was laid in a shallow pit and shaped charges were fastened to its casing (Figure 12). Detonation cord was used to initiate the shaped charges and the focused energy of the explosion breached the ordnance's casing. Only after a casing was breached could an item be conclusively classified as UXO or inert ordnance.

Figure 12. Ordnance prepared for disposal detonation
